NATIONAL PROGRAM FOR INSPECTION OF NON-FEDERAL DAMS
BELLAMY RESERVOIR DAM. (U) CORPS OF ENGINEERS WALTHAM
MA NEW ENGLAND DIV FEB 79

BELLAMY RESERVOIR DAM

PHASE I INSPECTION REPORT NATIONAL DAM INSPECTION PROGRAM

FEBRUARY 1979

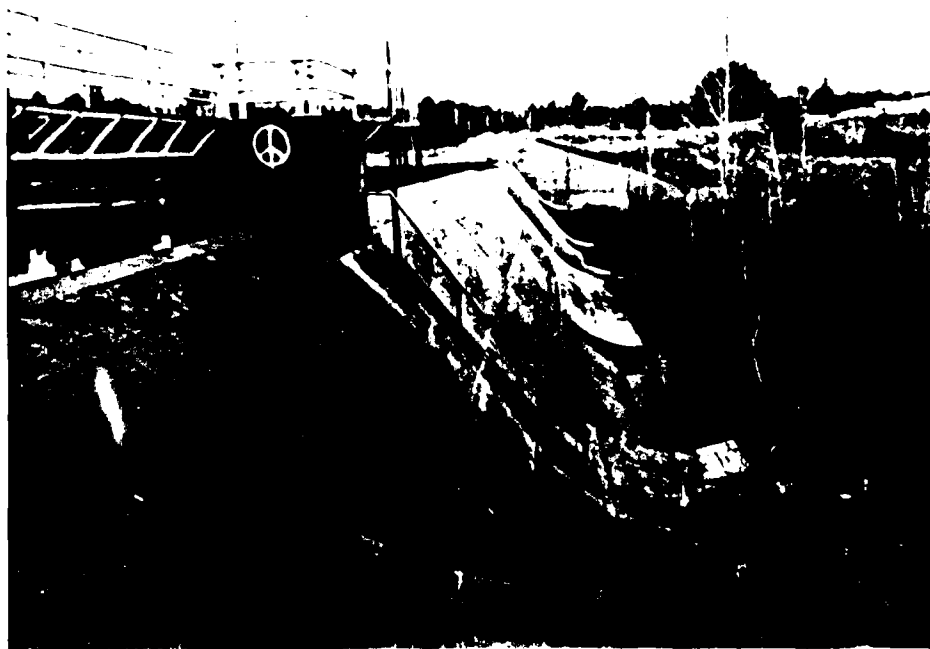
The spillway structure, shown in Photos 7, 8 and 10, consists of fourteen massive concrete segments, each 23 feet long, and two training walls. The concrete spillway surface is in good condition. There are, however, some surface cracks and efflorescence deposits, mostly concentrated around the construction joints, as can be seen in Photos 12, 13, 17 and 18. Field inspection of the training walls revealed concrete surface cracks and heavy efflorescence deposit on the left training wall (Photos 13, 14 and 15). Photo 14 indicates some spalling of the concrete surface.

PHOTO NO. 7 - Downstream face of spillway from right abutment.

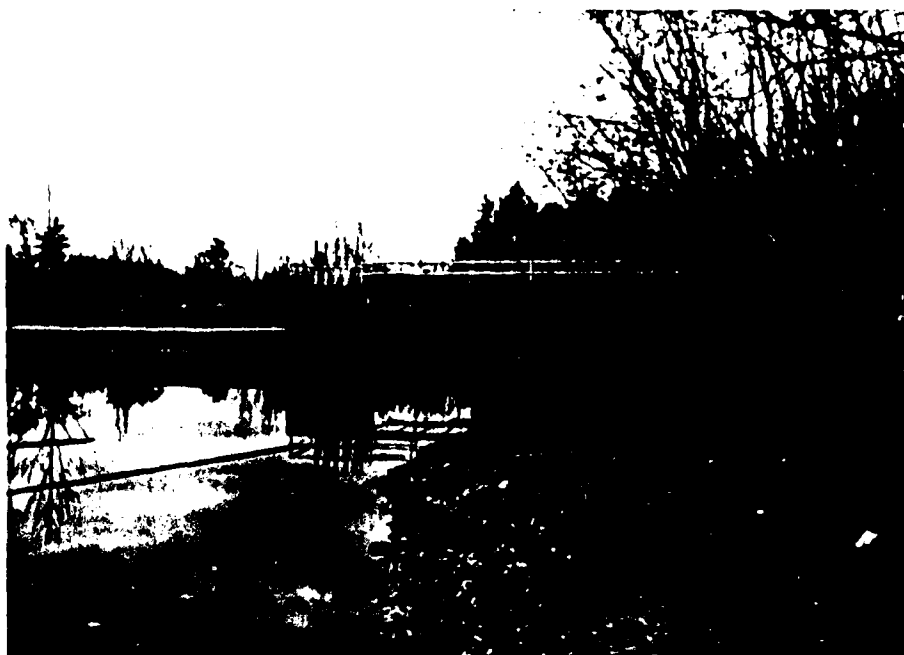
The service bridge to the gate chamber is a simple span truss structure consisting of WT4 standard shapes as the truss cords and 1½ angles as the truss diagonals. The floor consists of metal gratings, some sections of which are missing. The main carrying members, bearing plates, connections, roofing and floor are generally in good condition. The top and bottom truss cords, however, are rusted at the right abutment. The bridge is supported by the right training wall and the gate chamber. The concrete in both supporting areas is in good condition.

PHOTO NO. 19 - Outlet works structure with service bridges
from right bank of reservoir.

(c) The top and bottom truss cords of the service bridge at the right abutment should be refurbished and missing floor grating should be replaced.

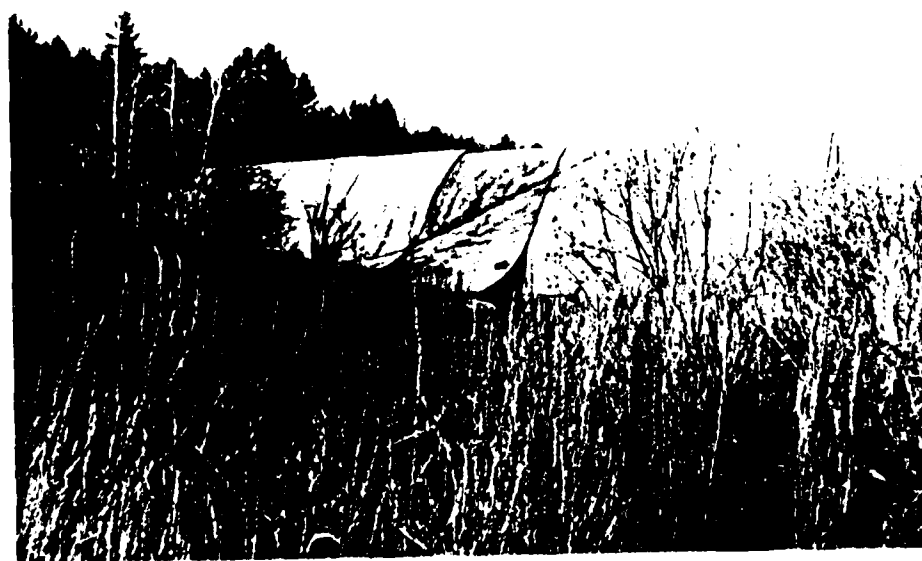
The spillway discharge channel is the original Bellamy River bed. Visual inspection of the discharge channel showed it to be in generally good condition. There were several fallen trees and light brush growth along the sides of the channel. The bed of the discharge channel could not be totally inspected as it was below water (caused by the small four foot high dam immediately downstream).

PHOTO NO. 20 - General view of discharge channel.

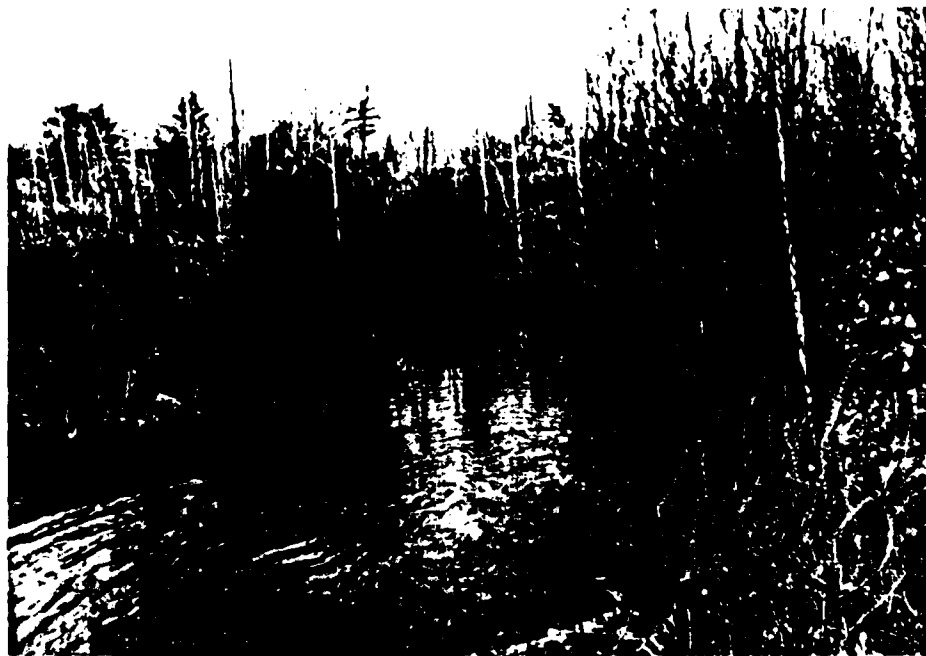
PHOTO NO. 22 - View looking downstream from spillway structure showing outlet works discharge channel.
